CONSEQUENCES OF INCORRECT DESIGN AND UNQUALIFIED REALIZATION ON RELIABILITY AND EFFECTIVENESS OF RADON REDUCTION MEASURES

*Martin Jiránek, Czech Technical University, Faculty of Civil Engineering, Praha
e-mail: jiranek@fsv.cvut.cz*

Factors responsible for failures of radon remedial and preventive measures were studied on several unsuccessfully protected houses. Presented paper tries to summarize sources of failures. Possibilities how to improve the effectiveness of failed measures are also discussed.

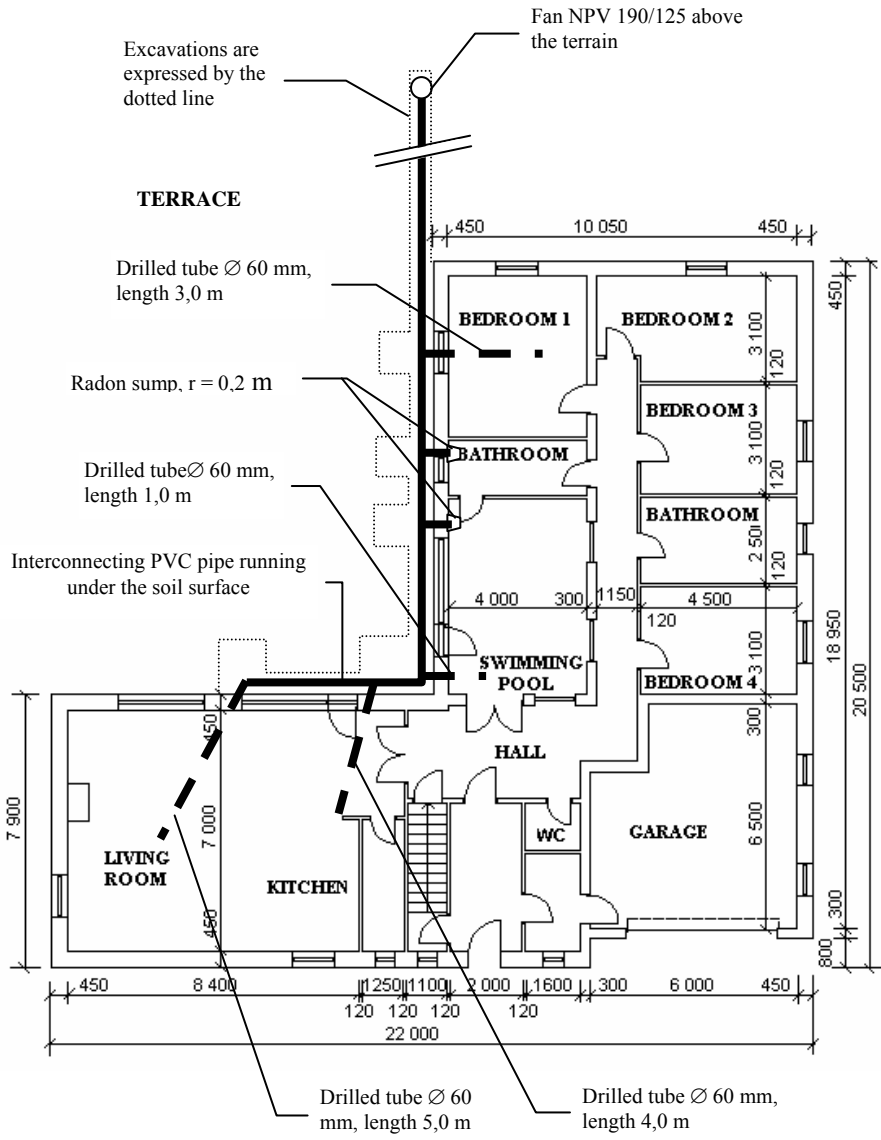
Fig. 1. Ground floor plan of the house with the soil depressurization

Indoor radon measurements carried out in the completed house showed concentrations from 782 Bq/m^3 to 1064 Bq/m^3 . Detailed investigation revealed that radon penetrates through the leakages in the radon-proof insulation, especially around pipe penetrations, since majority of them was installed additionally after the insulation had been laid. Furthermore, applied

insulation was not protected against perforation during following construction works. Besides poor workmanship also the design of the protection was not qualified. In spite of the fact that the Czech technical standard ČSN 73 0601 [4] requires ventilation of highly permeable sub-floor layers, in this case the ventilation of the sub-slab gravel layer was not designed.

Improving of the airtightness of the radon-proof insulation by sealing of leaky places would not be efficient, since it is highly improbable that we had succeeded in finding of all imperfections. Therefore the remediation was based on the active soil depressurization. The air from the subsoil is extracted by means of two radon sumps located under the swimming pool and the bathroom, where a lot of penetrations exist, and 4 perforated tubes drilled into the sub-floor gravel layer from the chase excavated along the walls adjacent to the terrace. Sumps and pipes are connected by a PVC pipe running in the soil to an exhaust fan located outside the house above the terrain (Fig. 1).

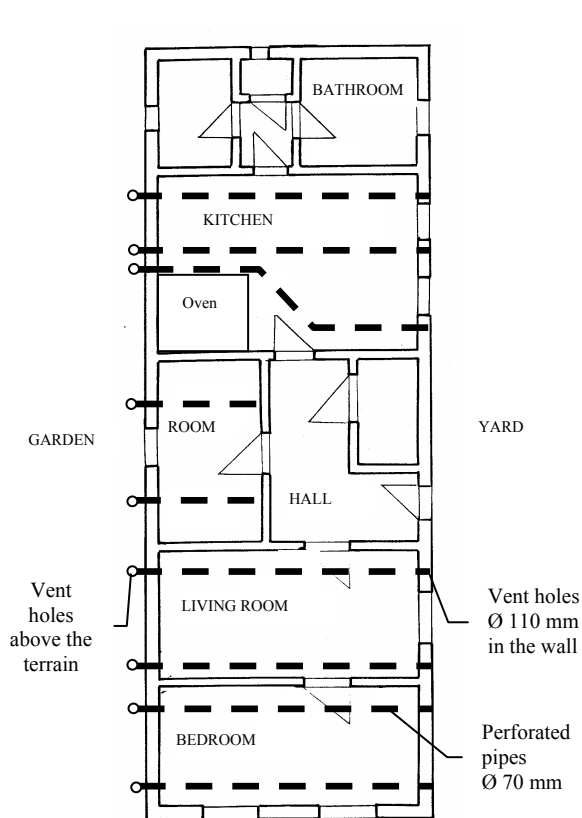
Fig. 3. Ground floor plan of the house with the soil ventilation system adopted during the first attempt at mitigation

Indoor radon measurements performed after the mitigation measures had been completed showed that the reduction was not sufficient, because radon concentrations reached up to 2098 Bq/m^3 . Detailed diagnostic measurements revealed that radon is transported mainly through wall/floor joints, where concentrations around 3 kBq/m^3 were measured [1]. No air movement inside the perforated pipes was observed. Radon index of the building site was determined as high (the third quartile of the soil gas radon concentration measurements is 160 kBq/m^3 , soil permeability is medium).

The main reason of the failure is the presence of the wall/floor gaps together with the inefficient soil ventilation system. Under certain circumstances (vent holes on windward side, outlets on lee side blocked by snow cover, etc.) the system can induce overpressure in the drainage layer (mainly on the windward side), which can enhance radon transport into the house. Drainage layer due to its high permeability also increases the radon transport compared to the original soil.

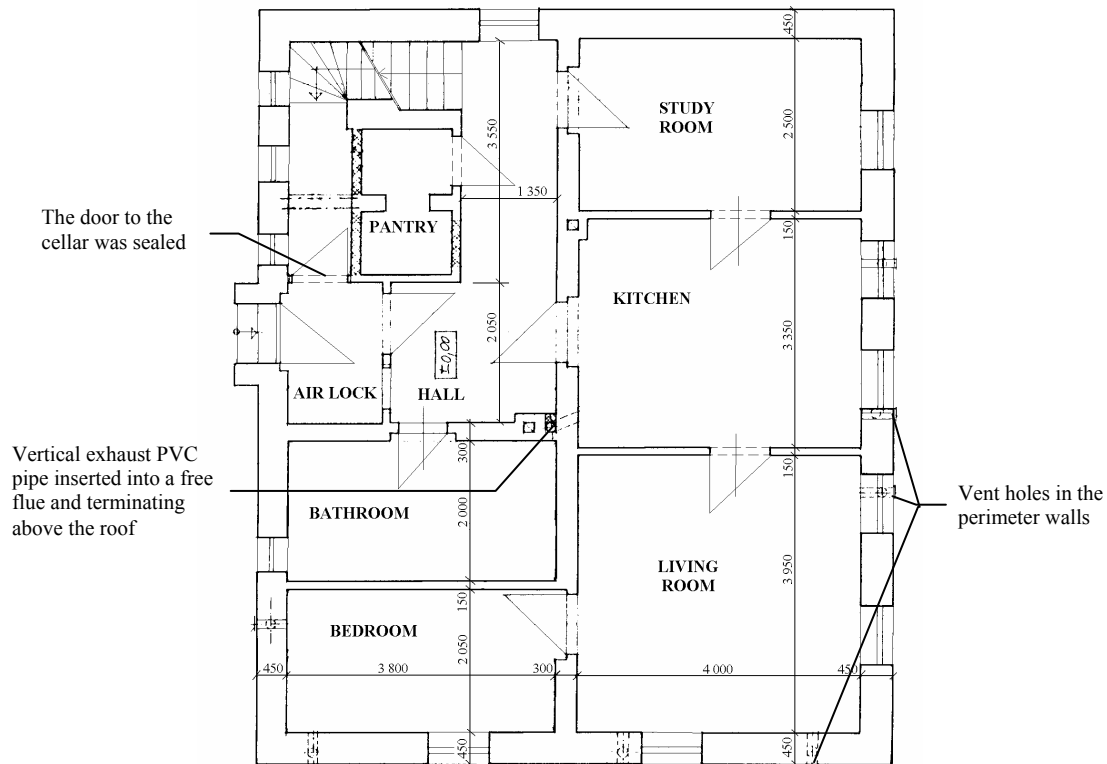
Fig. 5. Ground floor plan of the house with the layout of vent holes

Ground floor radon concentration registered immediately after mitigation by electrets exposed for 3 days varied from 680 Bq/m^3 to 850 Bq/m^3 . Concentrations measured 4 years later in 1998 by track detectors exposed for one year ranged from 720 Bq/m^3 to 1050 Bq/m^3 . Nearly the same values were obtained in 2006. This leads to the conclusion that the passive ventilation of the air gap within the ground floor is not efficient.

In 2006 the passive ventilation was changed into an active one by means of a fan installed at the top of the vertical exhaust pipe. All vent holes in the perimeter walls were blocked in order to achieve greater underpressure within the air gap. During active ventilation indoor radon concentration decreased well below 200 Bq/m^3 .

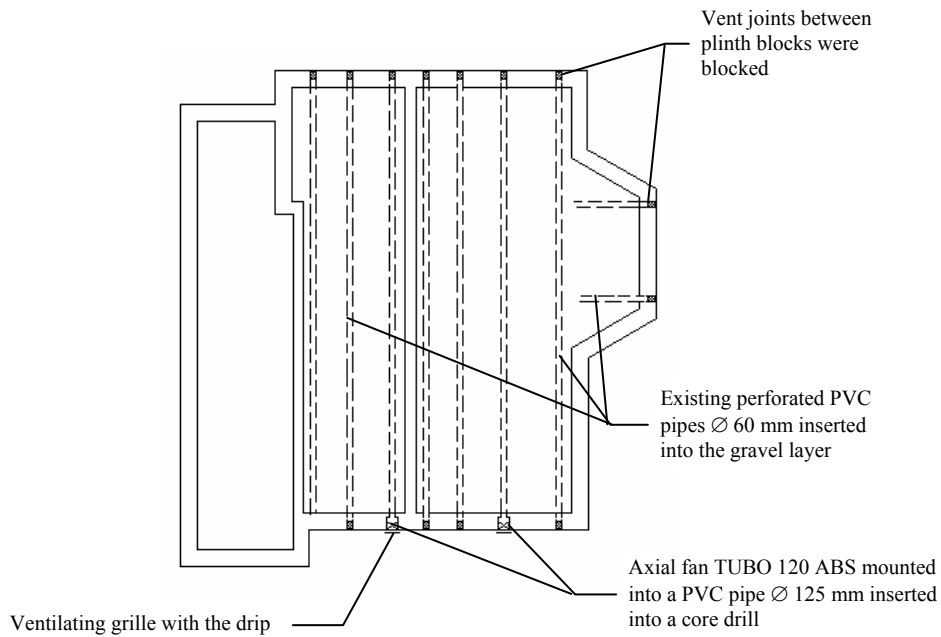
Fig. 7. Plan of foundations, layout of perforated pipes and location of fans

Ground floor radon concentrations measured immediately after the house had been completed ranged from 315 Bq/m^3 to 750 Bq/m^3 . Detailed investigation revealed that radon penetrates through unsealed joints in the radon-proof insulation and around pipe penetrations. This can be attributed to the unqualified design of the protective measures. According to the Czech technical standard ČSN 73 0601 it is not allowed to use plastic membranes with dimples for radon barriers, because it is nearly impossible to provide airtight joints between membranes. Passive soil ventilation through free joints between plinth blocks is in general not convenient, the less so for mountain regions, where the snow cover effectively blocks vent joints during the substantial part of the year.

Since sealing of leaky places in the radon-proof membrane is not feasible, the remediation was based on changing the way of soil ventilation into an active one. Since the sub-floor space under the habitable rooms was divided into two compartments, two small axial fans were used for the extraction of the soil air. Fans were inserted into core holes drilled in the plinth blocks at places, where are the chosen perforated pipes opened to the outdoors (Fig. 8). The remaining vent joints were blocked in order to achieve greater underpressure within the gravel layer. During active ventilation indoor radon concentration decreased well below 200 Bq/m³ (Fig. 9).
