MITIGATION OF INEFFECTIVE MEASURES AGAINST RADON

M. Jiránek^{1,*}, M. Neznal² and M. Neznal²

Reasons of low effectiveness of radon remedial measures have been studied on several unsuccessfully remediated houses. Based on the thorough analysis, factors responsible for failures are clarified. The possibilities of how to improve the effectiveness of installed measures are also discussed. Experience in this field is documented by several examples of additionally mitigated houses. After application of additional measures, indoor radon concentration in the studied houses decreased in average 5.3 times. Costs for additional mitigation were at least four times cheaper compared with costs required for installation of original measures.

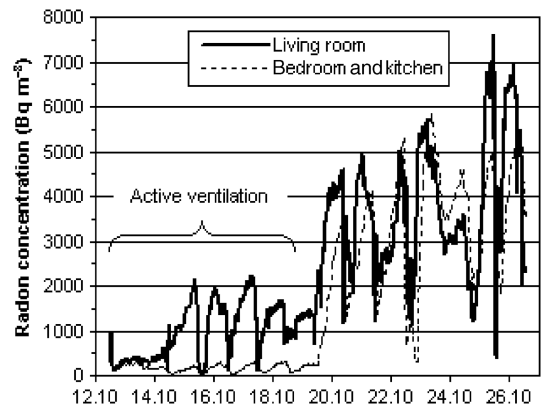
House no. 1: Detailed investigation revealed that the failure of the original measure could be attributed to the poor efficiency of the passive soil ventilation and radon exhalation from building materials.

Figure 1. Effect of active soil ventilation on radon concentration in two rooms. Radon still penetrates into the living room from the adjacent house through the dry sidewall.

House no. 2: Insufficient soil ventilation and radon penetration from the adjacent house were identified to be responsible for the poor efficiency of the original measure.

In 2006, the passive subslab ventilation was changed into an active one by means of a fan installed at the top of the vertical exhaust pipe. At the same time, vent holes in the perimeter walls were blocked. During active ventilation, indoor radon concentration decreased to the mean value 297 Bq m⁻³. The only exception is the living room into which radon penetrates from the adjacent house through the highly permeable sidewall (Figure 1).

In 2006, the passive subslab ventilation was changed into an active one with the help of a fan installed at the top of one of the vertical exhausts. Vent holes in the perimeter walls were blocked in order to ensure higher underpressure in the subfloor layer. During active ventilation, indoor radon concentration decreased to the mean value 526 Bq m⁻³. This result is still influenced by the radon exhalation from building materials, which was not affected by the applied measure.

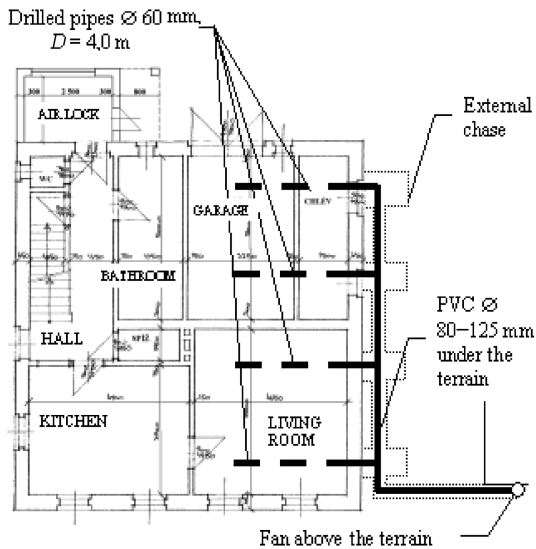
House no. 4: Results of the diagnostic measurements led to the conclusion that the inefficient passive ventilation of the floor air gap is responsible for the failure of the original measure.

Figure 2. Subslab depressurisation system based on four perforated pipes drilled under the existing floors from the external chase excavated along one side of the house.

Since the original measure did not comprise the vertical exhaust pipe, the improvement of the air gap ventilation by adding a fan would be complicated. Therefore, the additional measure was based on the installation of the active subslab depressurisation system. The soil air is extracted by means of four perforated pipes drilled beneath the existing floors from the chase excavated along one side of the house (Figure 2). Perforated pipes are connected to a fan by

a PVC pipe running in the chase. The fan is installed above the terrain at a distance of 3 m from the house. All vent holes in the perimeter walls were blocked in order to ensure greater underpressure in the subsoil. During active ventilation, indoor radon concentration decreased well below 200 Bq m^{-3} (Figure 3).

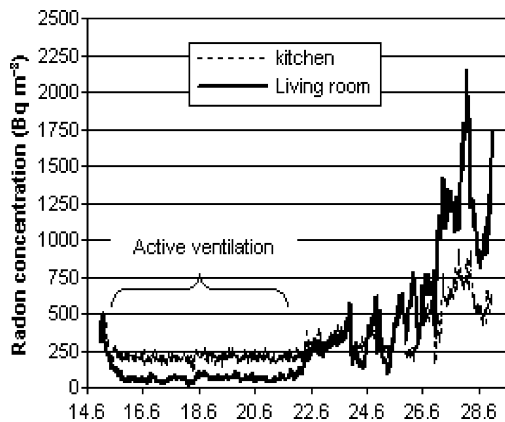
Figure 3. Effect of subslab depressurisation on radon concentration in two rooms.

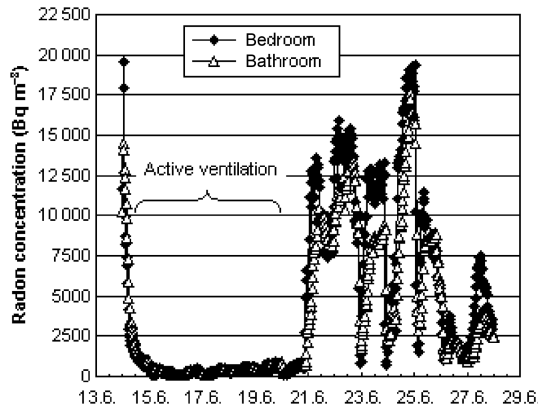
House no. 5: Low efficiency of the original measure was attributed to the poor ventilation of the floor air gap and loose joints between sheets of the HDPE membrane that serves as the radon-proof insulation.

Figure 4. Effect of converting the passive air gap ventilation into an active one.

In 2007, the passive ventilation of the floor air gap was converted into an active one by means of

connection of all vent holes on one side of the house to the fan. Vent holes on the opposite side of the house were blocked. During active ventilation, indoor radon concentration decreased well below 400 Bq m^{-3} (Figure 4).

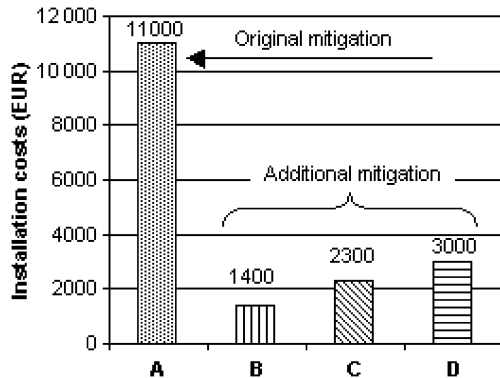
Figure 5. Comparison of installation costs. (a) Costs for the original measure, (b) a fan mounted on the existing vertical exhaust pipe, (c) vertical exhaust pipe is not a part of the original measure, (d) costs for the completely new remediation; existing measure cannot be used at all.

Comparison of installation costs for original and additional measures is presented in Figure 5. It can be seen that installation of additional measures was at least four times cheaper than installation of original measures. Costs for additional measures differ according to the fact whether the original measure could be used for the additional mitigation or not. Enormous costs for original measures can be attributed to the reconstruction of the floor structures in direct contact with the soil, because 12 y ago it was believed that a radon-proof membrane could create a sufficient protection against radon even in the existing houses. New floors usually comprised gravel layer, blinding concrete, radon-proof membrane, thermal insulation, hardboard and a floor covering. Two years ago, when the additional measures were applied, the preference was given to the measures based on active soil or floor air gap ventilation, because it was certain that a radon-proof membrane could not provide an effective protection.
